**Rentricity – Aquarion Water Energy
Recovery Pilot Study**

July 2007

RENTRICITY INC. RENEWABLE ENERGY RECOVERY AQUARION WATER PILOT PROGRAM 2004-2006

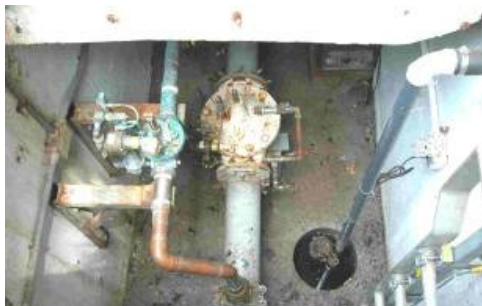
The Original Newfield Regulator and In-Vault Turbine Configuration Design

Rentricity in coordination with Aquarion Water Company installed a micro-turbine generator and associated appurtenances at a vault located on Newfield Avenue in Stamford, CT. A tee fitting was installed on the upstream side of the existing pressure reducing valve (PRV) and a new 10 inch class 53 cement lined ductile iron pipe was fitted to it. A 40 kW Flow-to-Wire turbine generator measuring 24-inch in diameter and 45-inch high was installed on a new 10-inch pipeline. The unit is made mostly of cast iron and stainless steel materials. A butterfly valve was installed on both new and existing pipes downstream of the tee connection to isolate the water flow during emergency situation. When the generator is activated, the butterfly valve on the existing pipe is closed to allow the water to pass through a new 10-inch pipe that would spin the impeller of the micro-turbine and energize the generator to produce electricity. The discharge from the micro-turbine generator is diverted back to the existing pipe just upstream of the PRV. The water passes through the PRV and flows through the distribution line that serves the customers in downstream area.

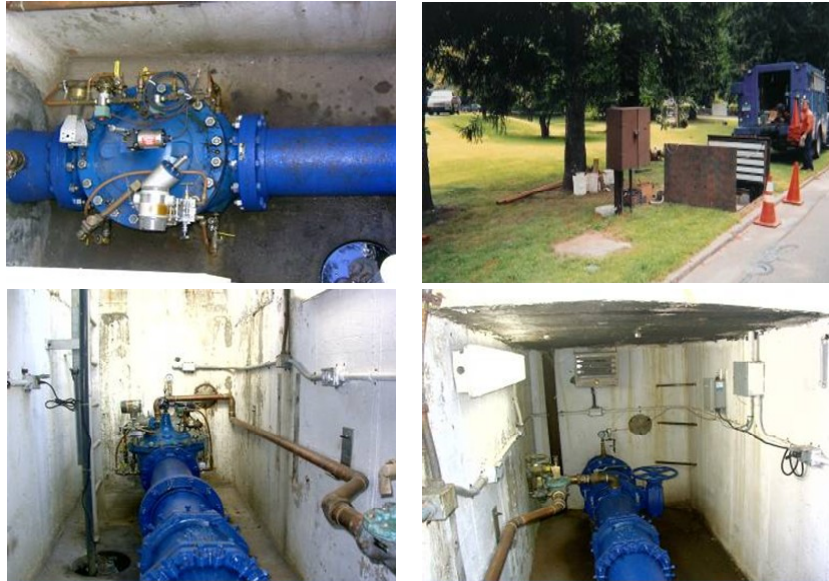
Aquarion Site Preparation - New PRV Installed

Stamford Pilot Program Site: 5' by 15' Vault with 8-inch Main and Claval PRV Located Next to Road with Electricity Available on nearby Utility Pole

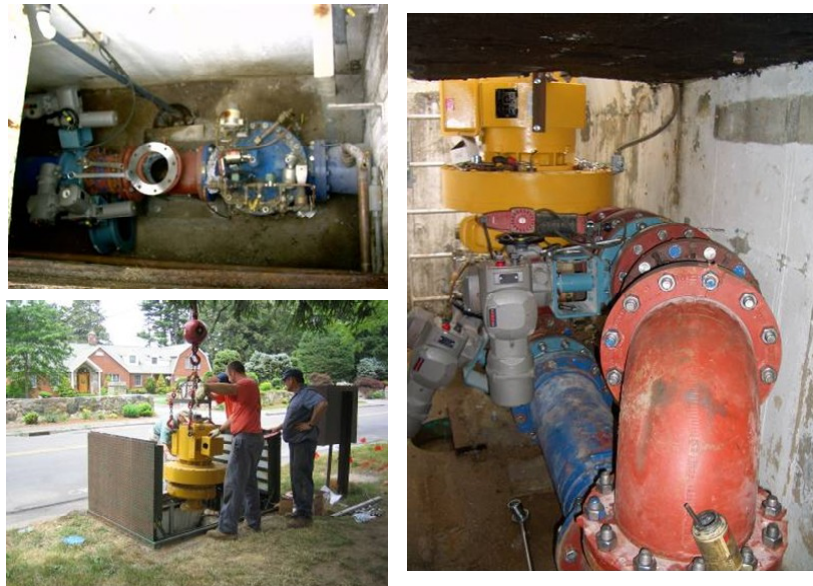
Aquarion Mechanical Installation

Stamford Pilot Program Site: Tee Flange installed Upstream of PRV Installed Flow-to-Wire Turbine, By-pass piping & electronic valves

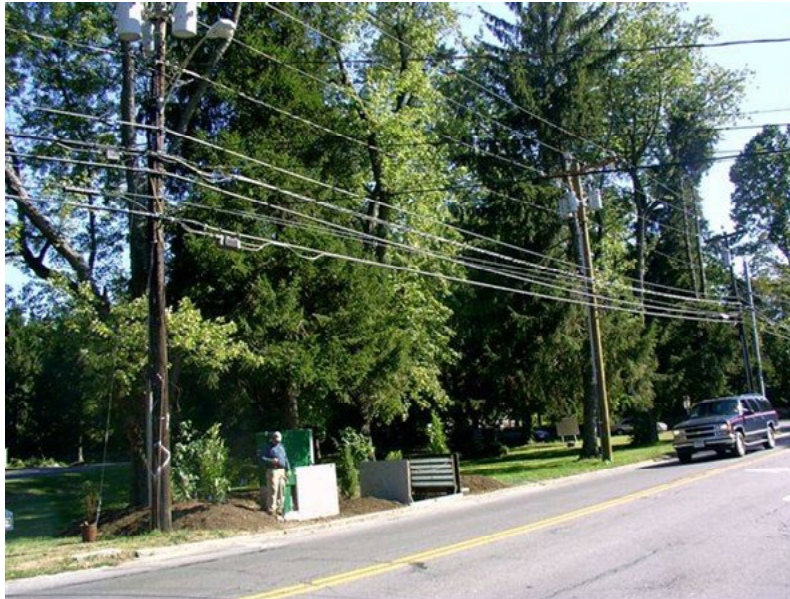
Completed Installation – October 2006

Stamford Pilot Program Site: Completed installation with 3 Single Phase Transformers, Underground Turbine, and Above Ground Control Panels
